# **Full Maxillary Arch Rehabilitation of a Severely Worn Dentition with Collapsed Bite Using Metal-Ceramic Fixed Prosthesis: A Case Report**

**Dr. Dinesh Kumar Dudeja<sup>1</sup>, Dr. Moni Bhargava<sup>2</sup>  
Dr. Anupam Bhargava<sup>3</sup>, Muskan Goel<sup>4</sup>, Dr. Prem Tiwari<sup>5</sup>**

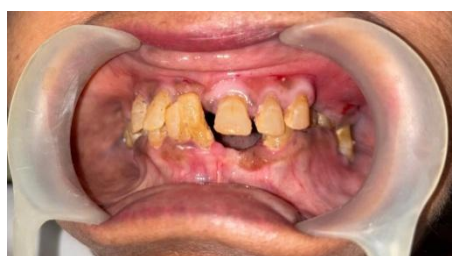
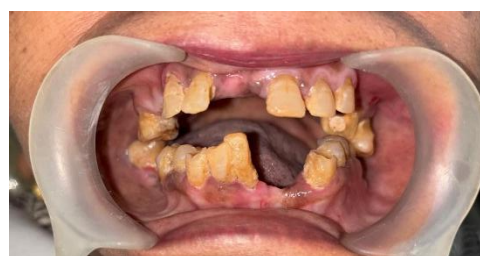
Pre operative intraoral picture

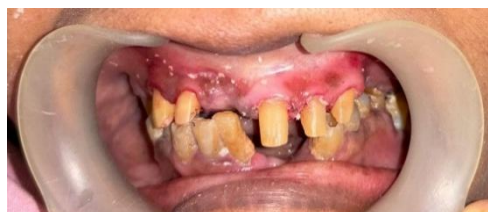
Crown preparation for metal ceramic restoration irt maxillary arch

All existing teeth were prepared to accept full veneer metal ceramic restorations with equigingival chamfer margins. The provisional fixed restorations were cemented with temporary cement (Freegenol Temporary Pack; GC Corp., Tokyo, Japan) and esthetics and emergence profile was evaluated. It was noticed that the crown height was insufficient and the patient had a collapsed bite. The provisional were temporarily removed. Bite was taken at the same height as the previous height of teeth.

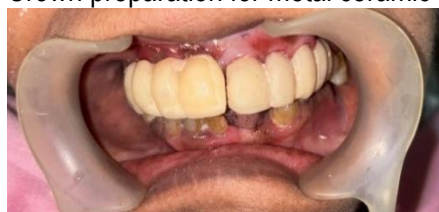
Provisional crown

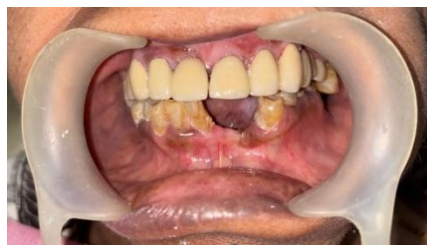
After placement of metal ceramic restoration irt maxillary arch

Final restoration was placed.
